Navajo Abandoned Uranium Mine Site Screen Report

Haystack No. 2 AUM Site

Navajo AUM Eastern Region

Weston Solutions, Inc.

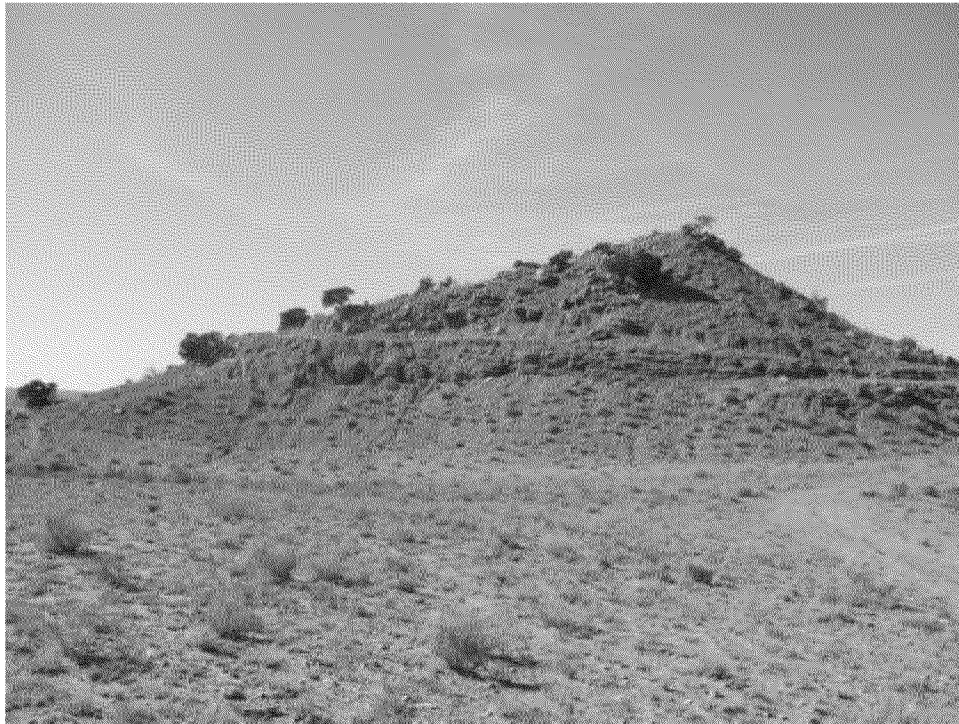
Photo 1. Haystack No 2 mine site, towards the west

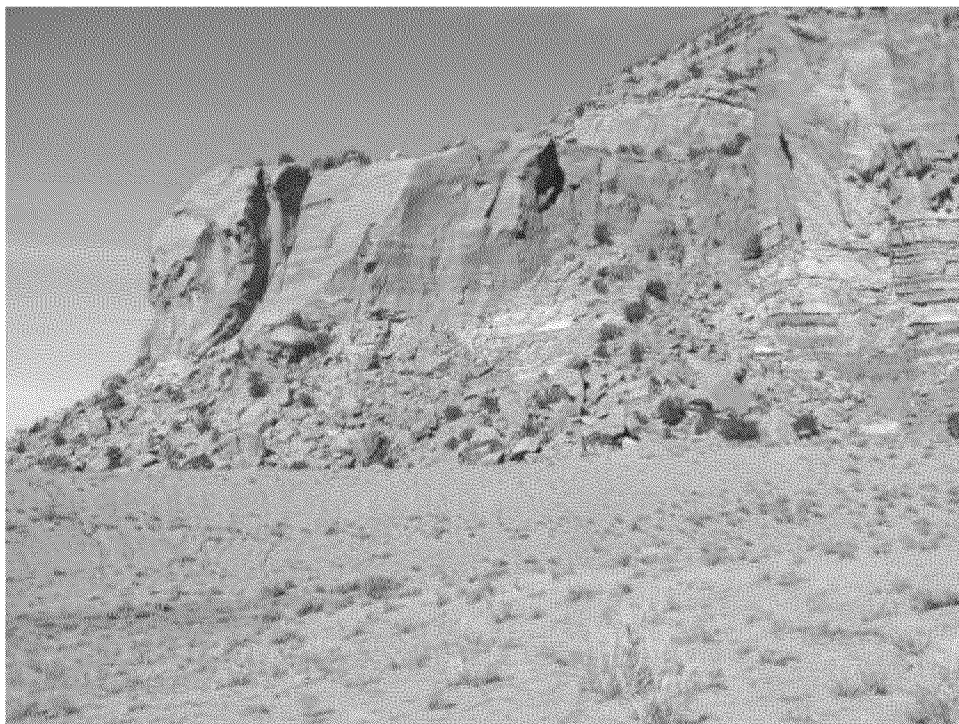
Reclamation status of the mine sites are currently unknown. No visible signs of reclamation were observed. A large recessed area in the center of the site may have been used as an open pit (Photo 2). No waste piles, adits, or other mine features were observed during the site visit.

Photo 2. Haystack No 2 mine site and open recessed area, towards the north

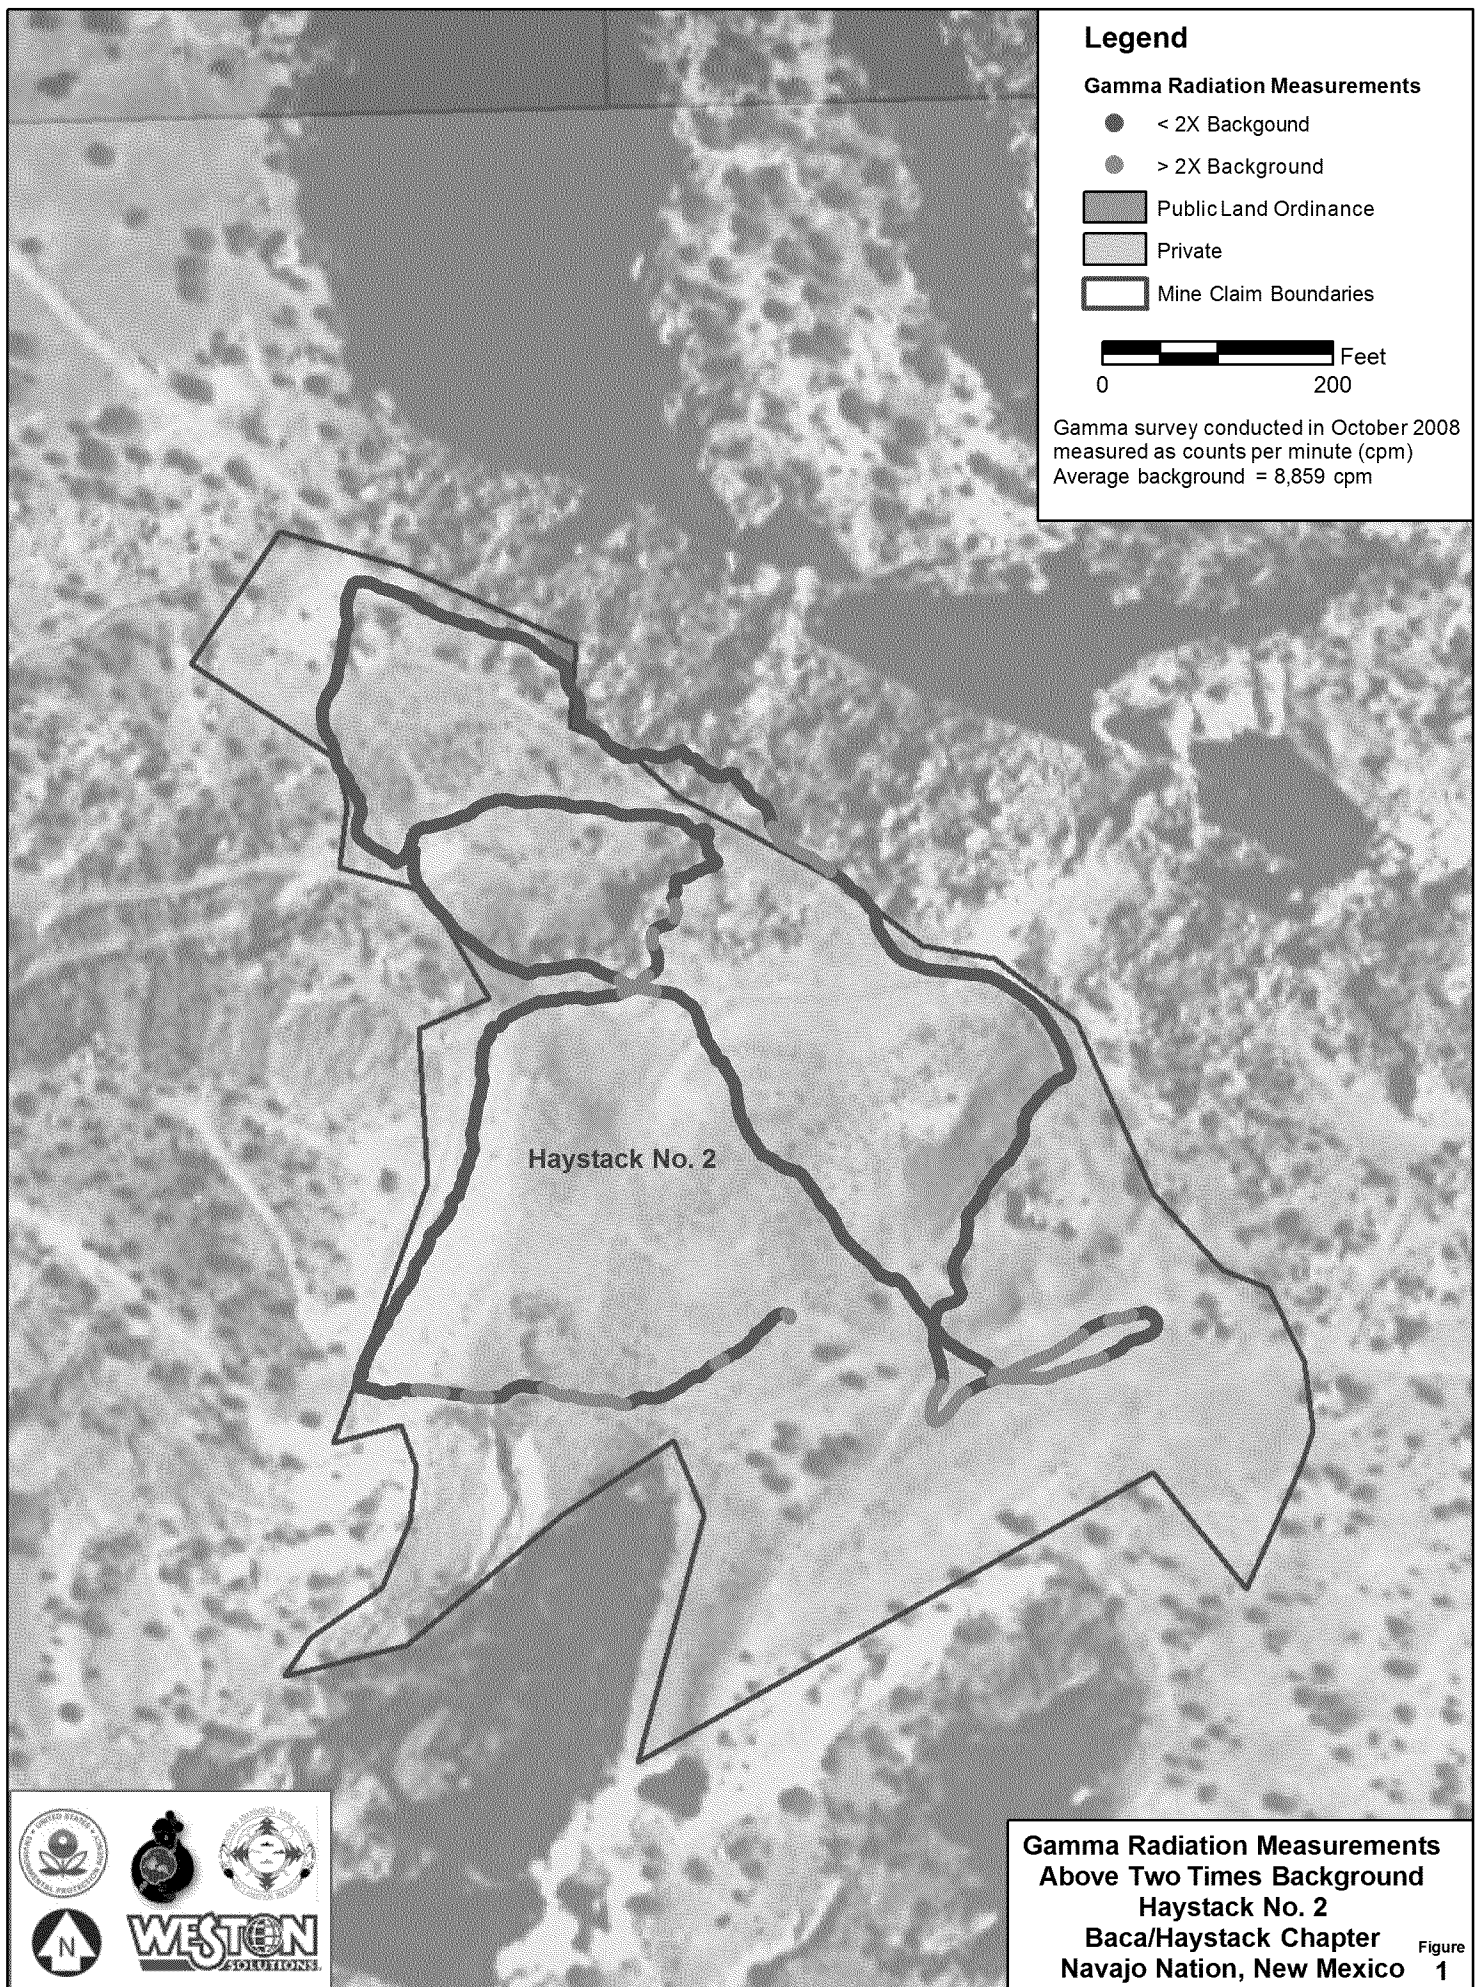
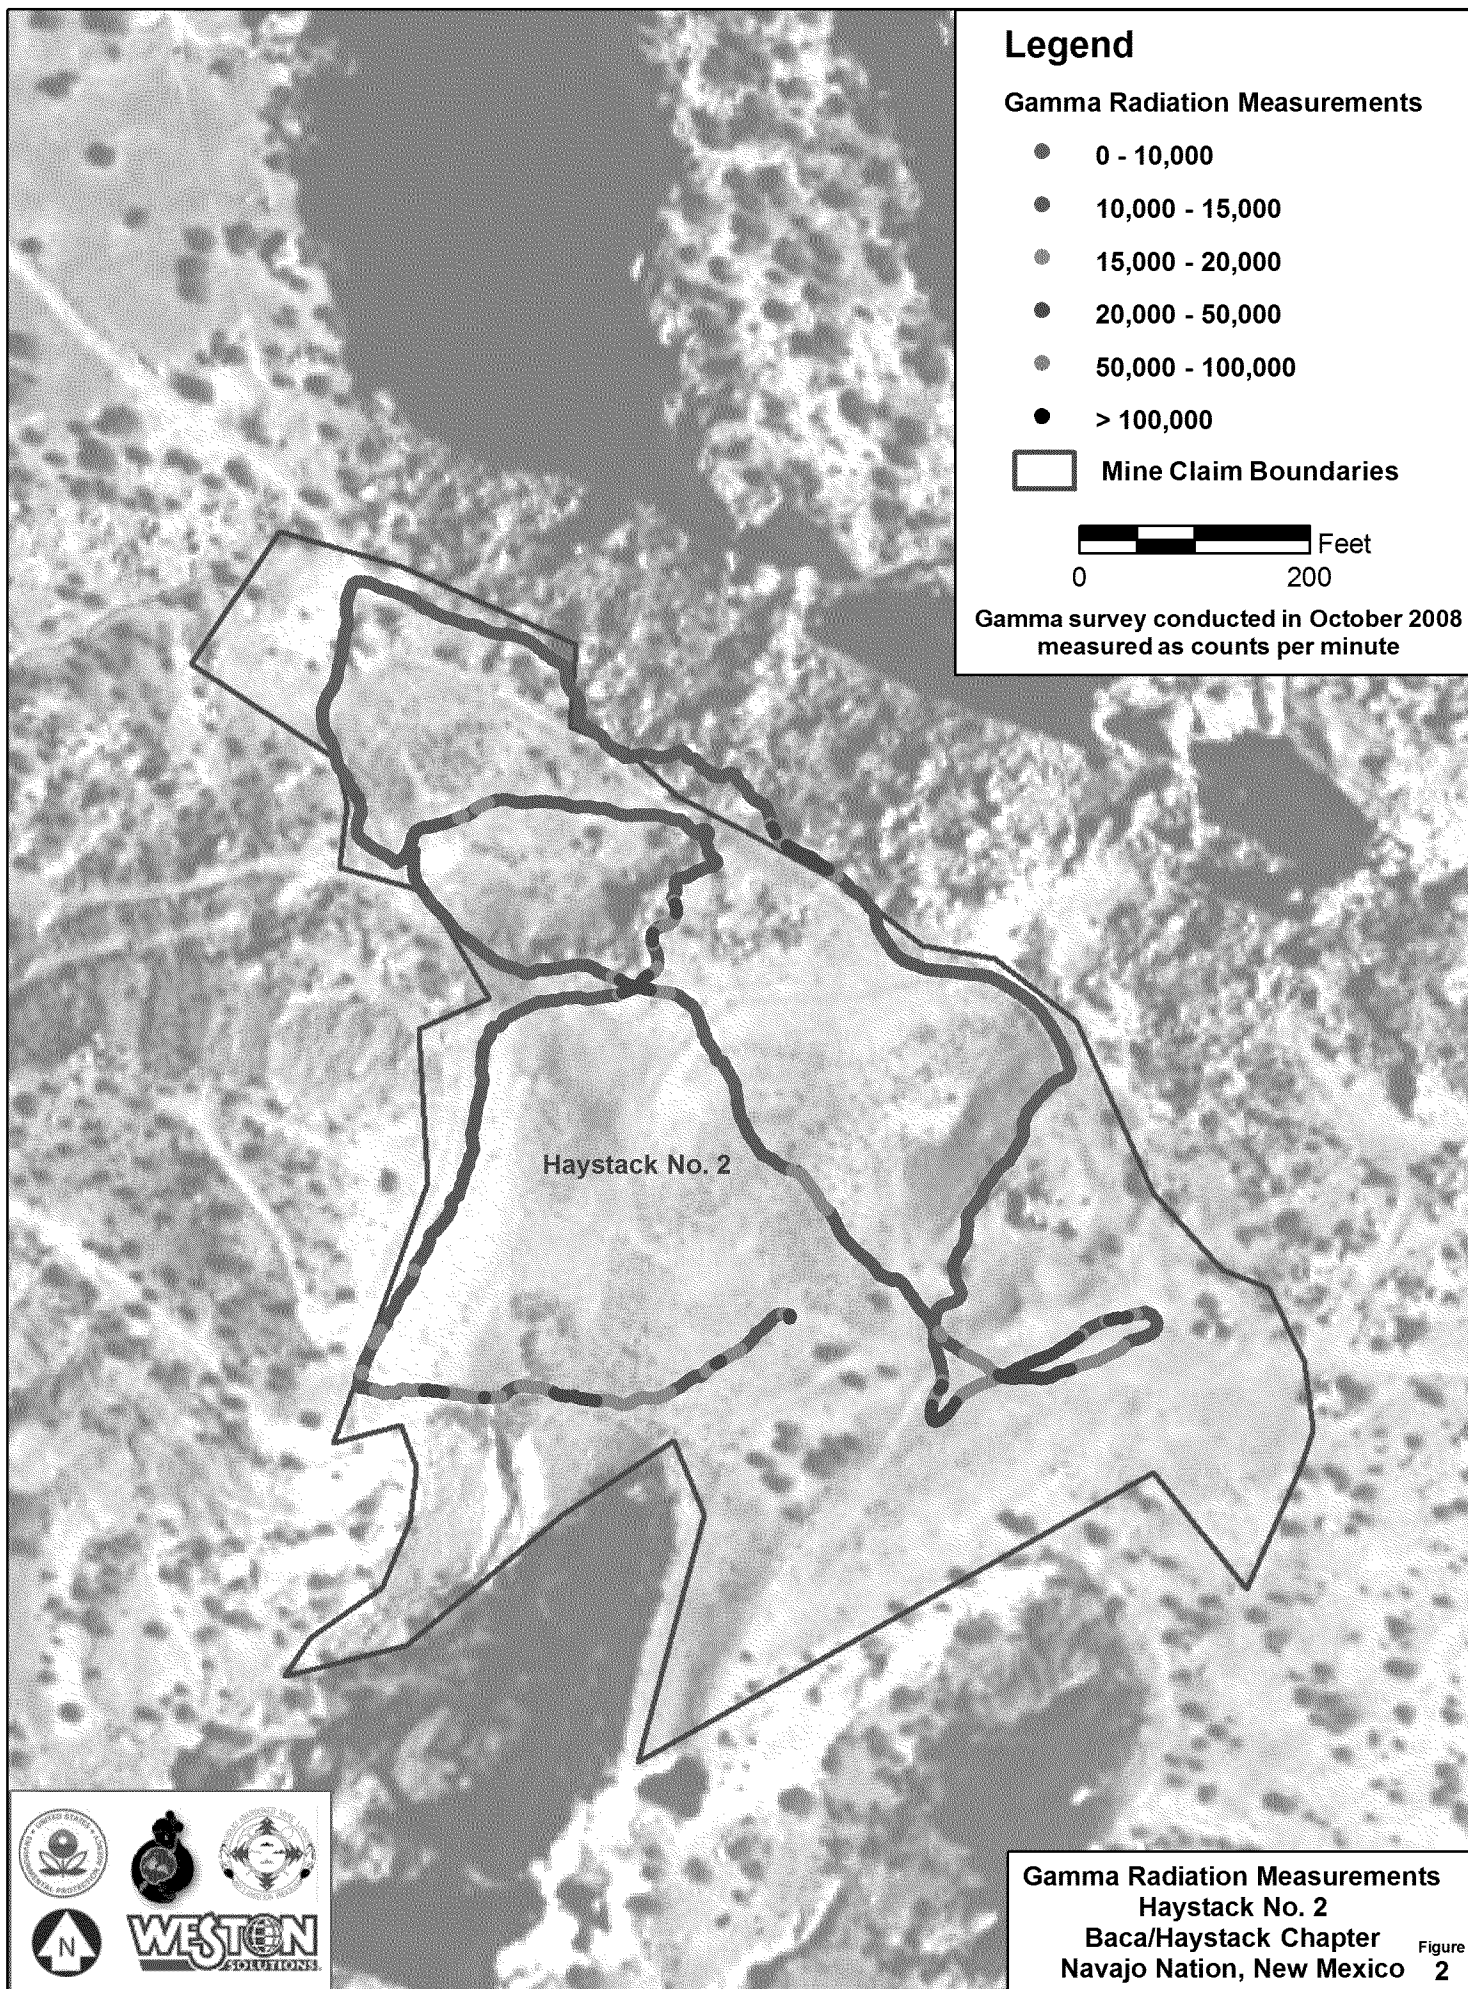
Mine site: Haystack No. 2
- See Figures 1 and 2

A total of 1,210 gamma radiation measurements were collected from the mine site, ranging from 6,155 cpm to 32,732 cpm. The measurements are represented in Figures 1 and 2. Radiological measurements collected for the New Mexico Mining and Minerals Division during a 2008 field screening survey found gamma radiation levels near the ground surface with a maximum of 90 micro Roentgen per hour ($\mu\text{R/hr}$) and a minimum of 10 $\mu\text{R/hr}$, levels at the 4-foot elevation with a maximum of 60 $\mu\text{R/hr}$ and a minimum of 9 $\mu\text{R/hr}$, and background levels of 10 $\mu\text{R/hr}$.
